## Throop Fisheries Enhancement at Glen's Weir August 2011 Dorset Stour at Holdenhurst

### Completed Project

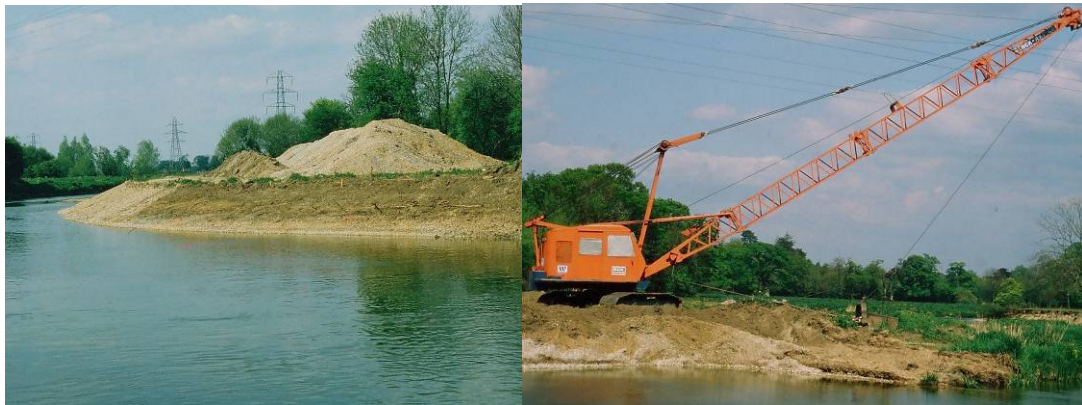
### **Dredging at barbel corner at Throop Fishery in the 1970's**

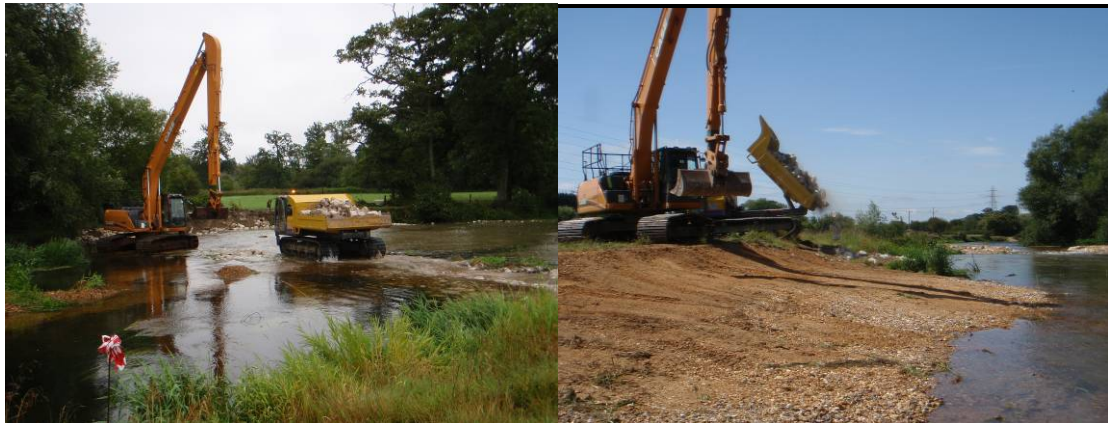
### **Midge and Mike re-profiling the weir and gravels**

The project was completed with the use of a 50' 360 reach machine digger in the expert hands of craftsman 'Midge' together with a 360 tracked dumper driven by Mike Clements from Ops delivery. Nearly 600 tonnes of Portland stone were placed into the collapsed bank, old weir and in channel as flow deflectors together with gravel re-instatement and re-profiling. Fry refuge areas were also created behind flow deflectors diversifying habitat for juvenile and adult fish species. The area was then fenced off to prevent cattle poaching and angler access into this area has been retained by installation of a gate into the enhancement area.

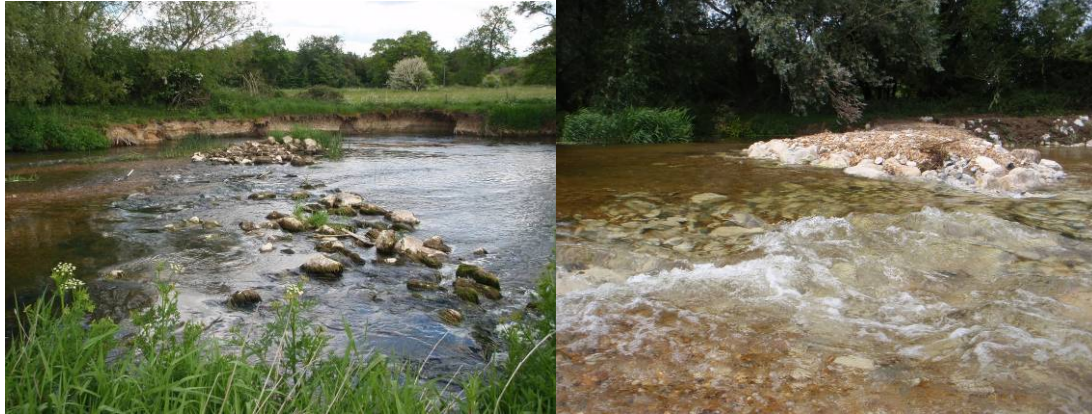
## **Glens Weir before and after re-profiling and bank stabilisation**

The end result has led to increased flows over a known spawning area by placing of a block stone deflector above Glen's weir, created a 30m riffle and shallow glide downstream of the weir by re-using gravels previously dredged from the bank side, and installation of another block stone deflector at the tailrace of the weir pool. These combined works together with re-profiling of the weir itself have increased flows over these spawning and juvenile habitat areas and created holding features for larger adult species within the weir pool itself. As flows are now concentrated in the middle of the channel, less scouring of the bank will occur retaining clean gravels throughout the year.

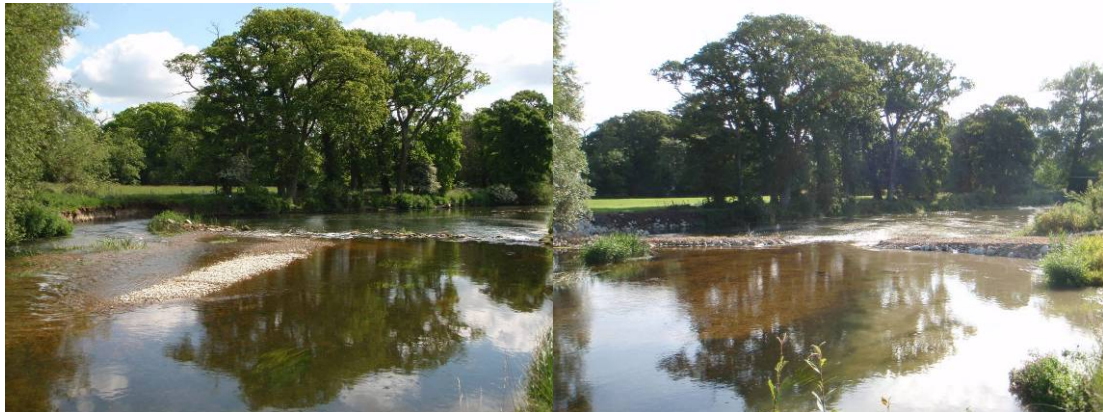
**Upstream gravels before and re-profiling**

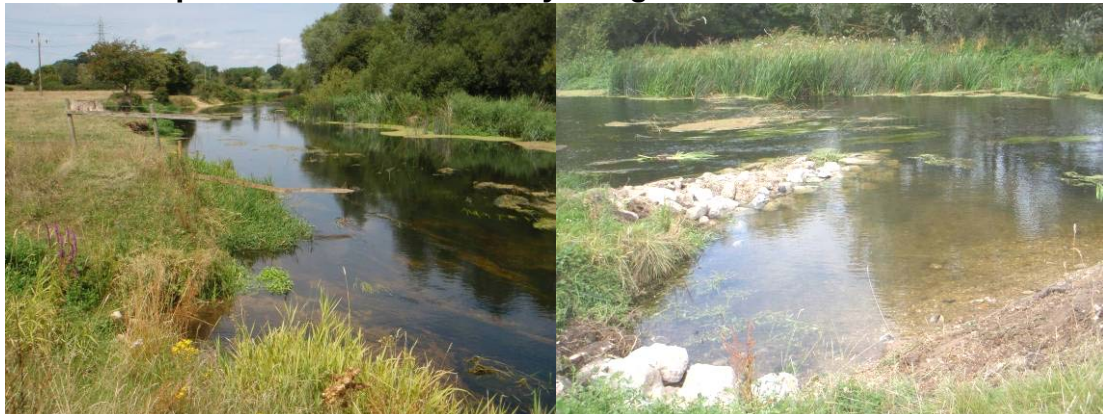
**Upstream deflector and fry refuge area before and after**

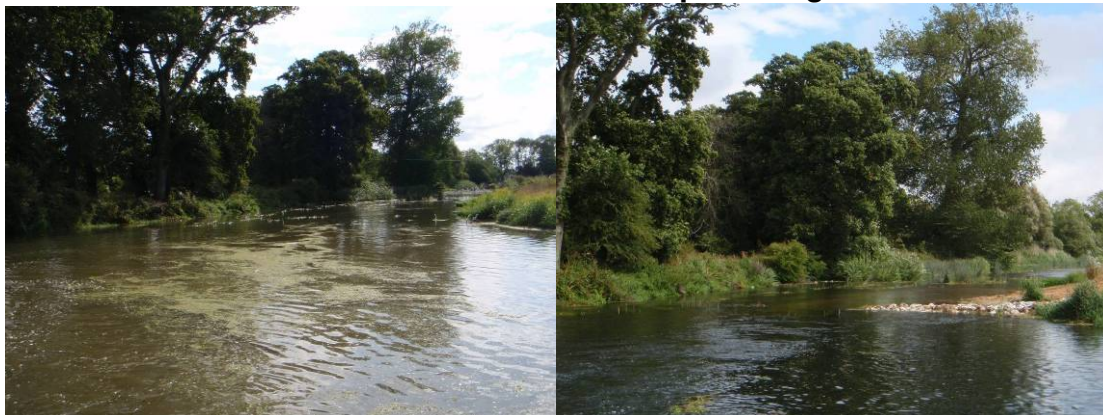
**Downstream deflector and re-profiled gravels**

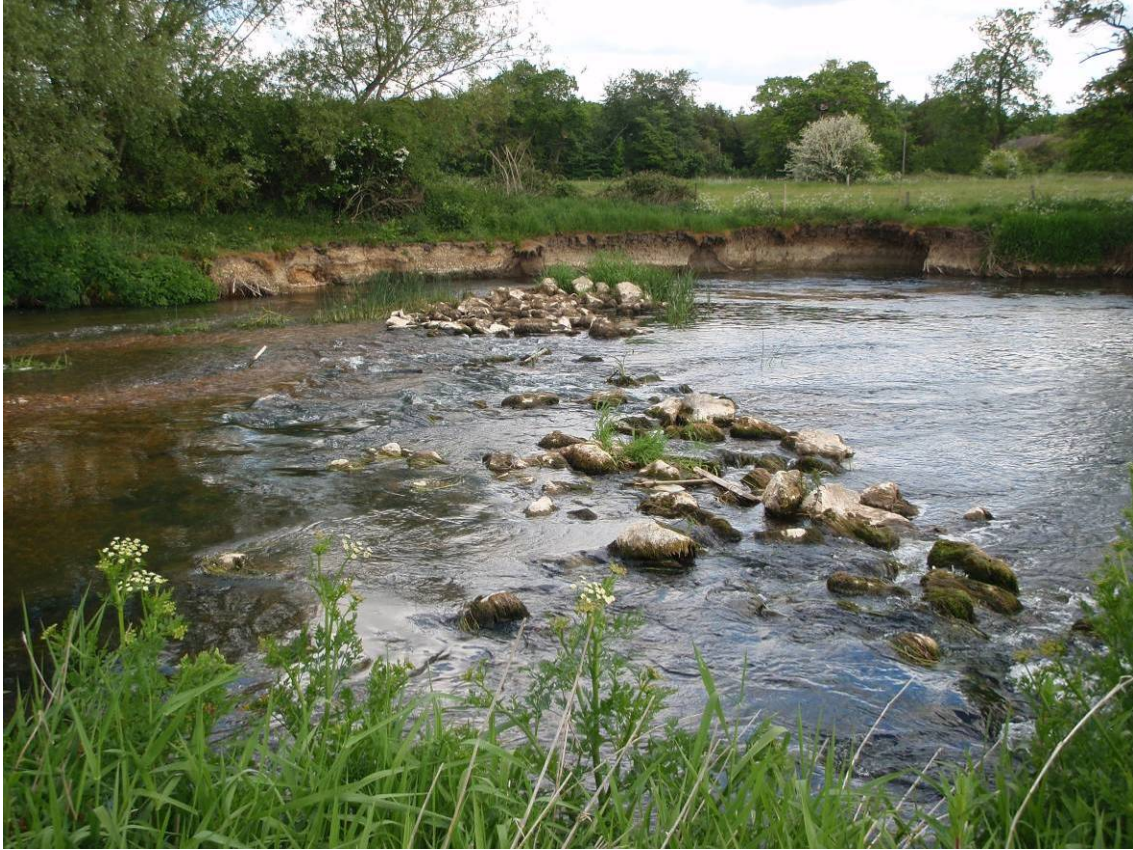
**Photo 1. Glens Weir before and after re-profiling and bank stabilisation**

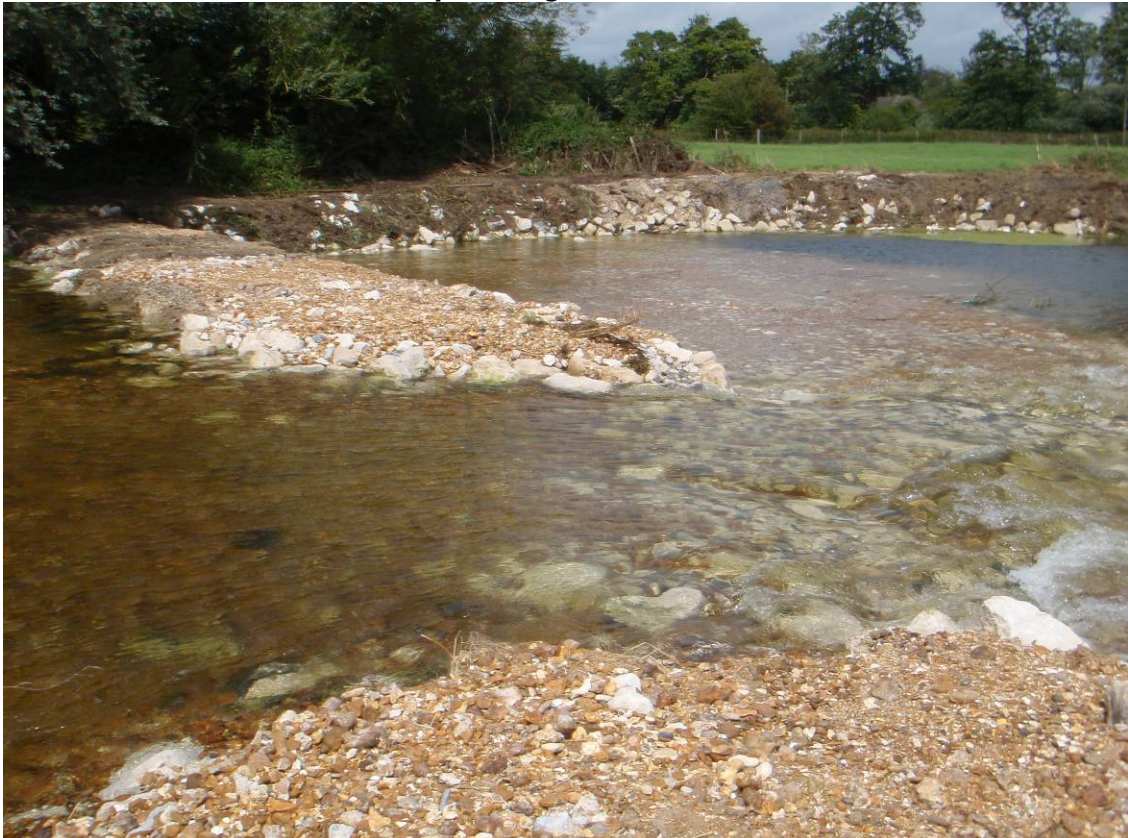
**Photo 2. Glens Weir after re-profiling and bank stabilisation**

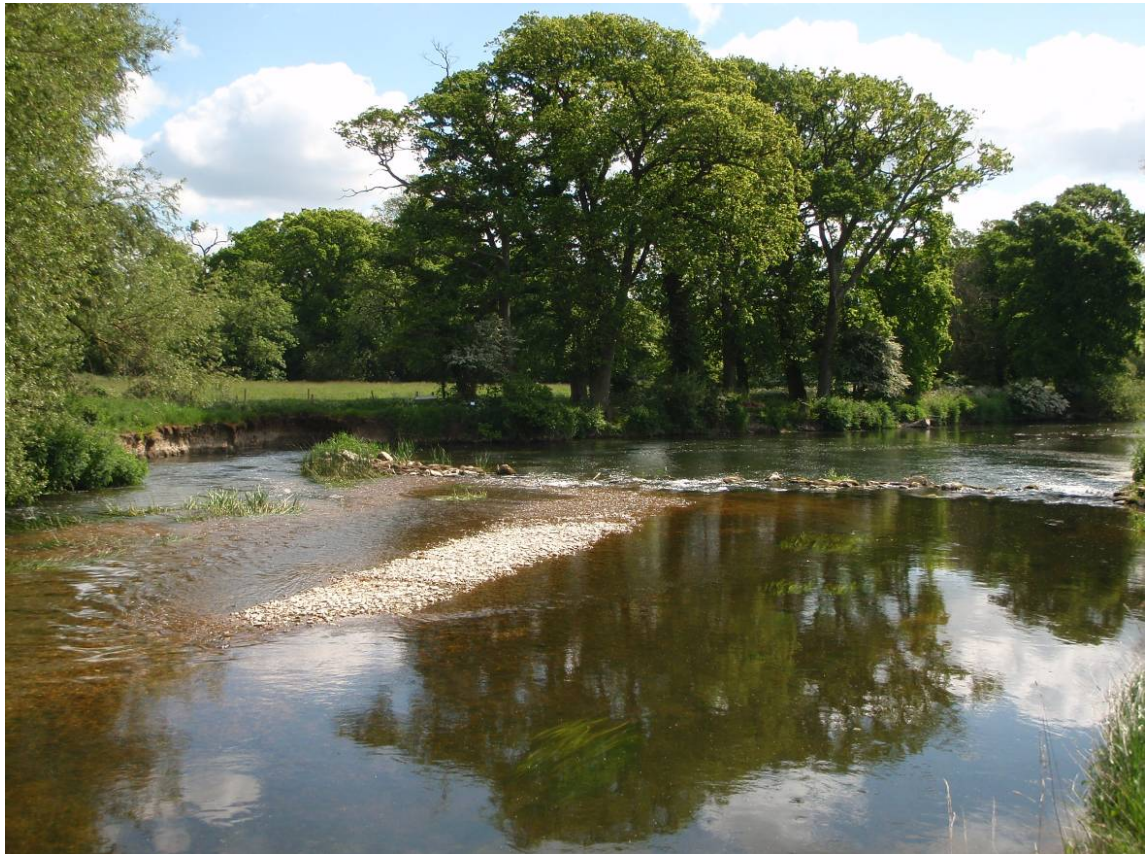
**Photo 3. Upstream gravels before re-profiling**

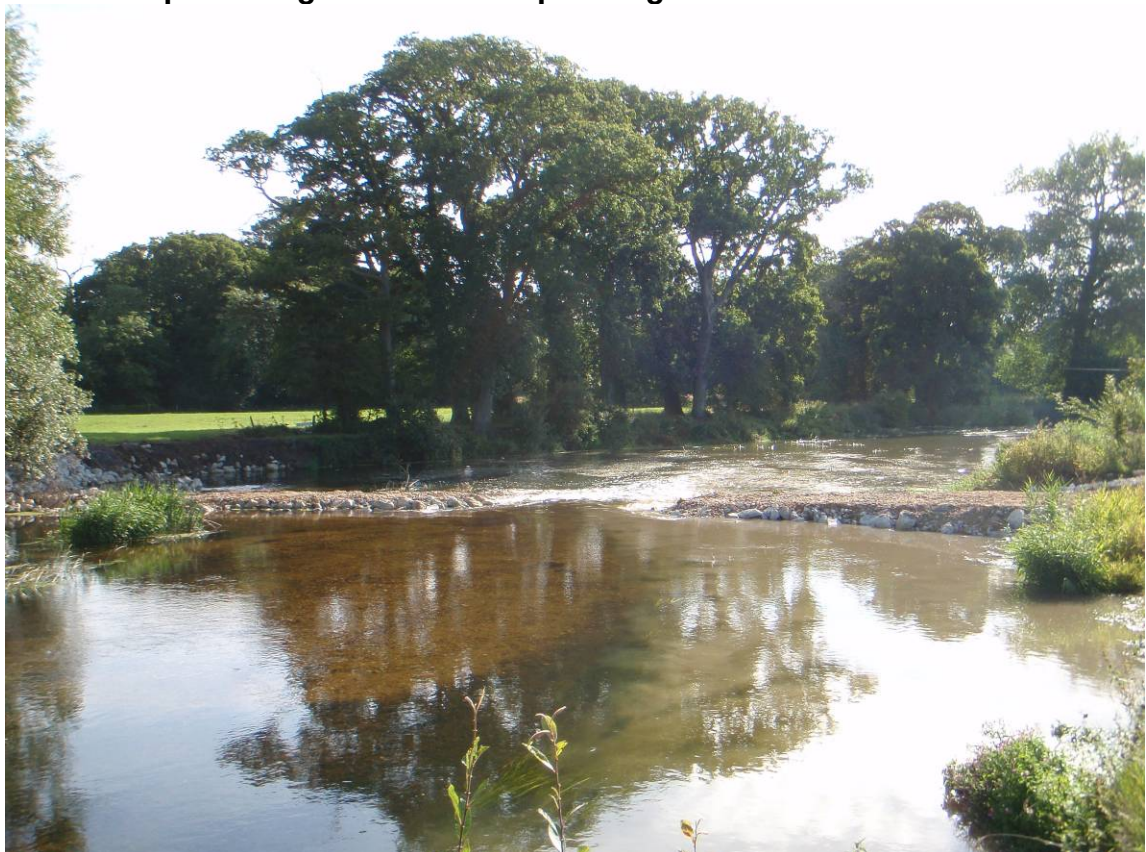
**Photo 4. Upstream gravels after re-profiling**

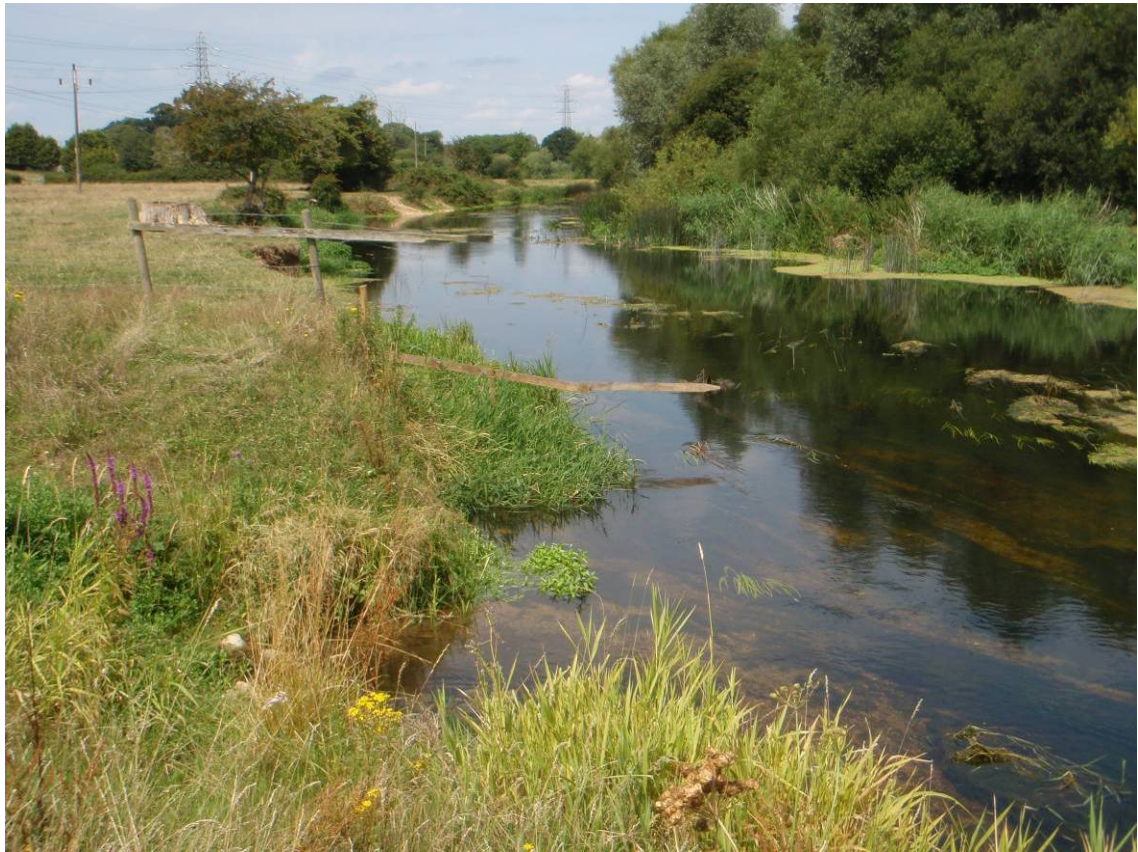
**Photo 5. Upstream deflector location and fry refuge area before works**

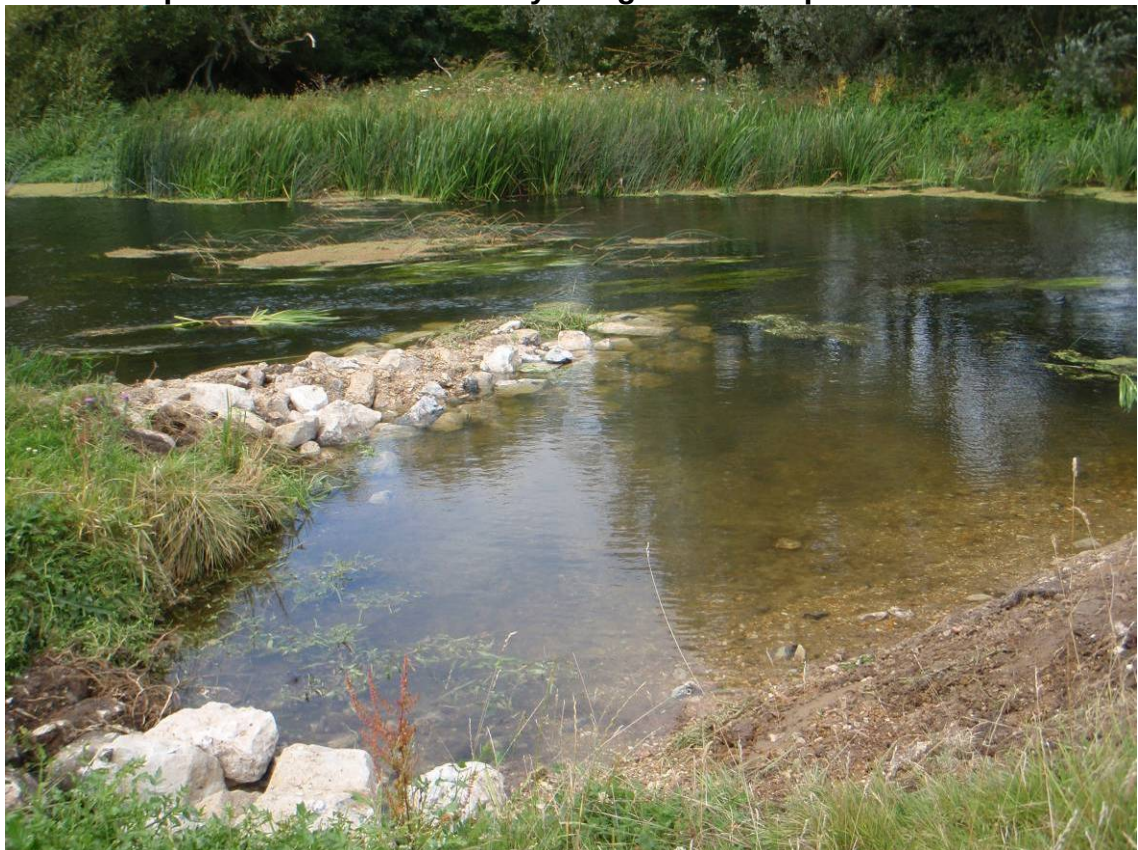
**Photo 6. Upstream deflector and fry refuge area completed**

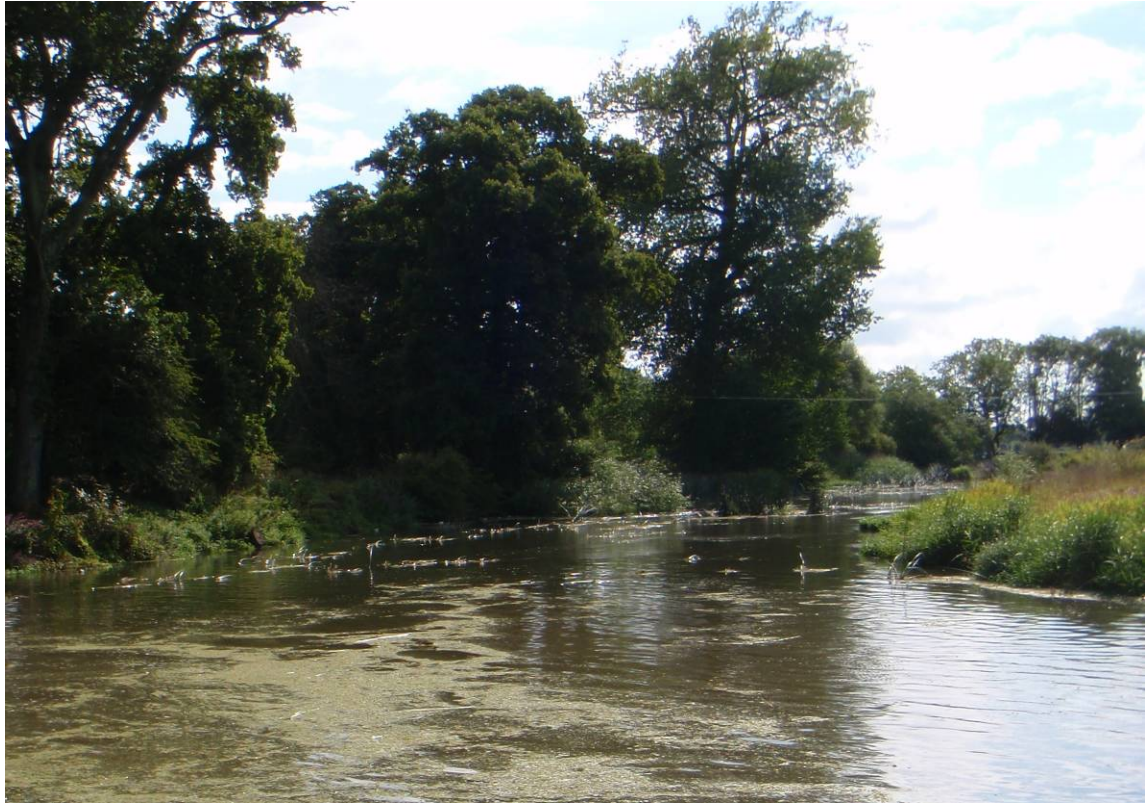
**Photo 7. Downstream deflector location and gravel re-profiling area before works**

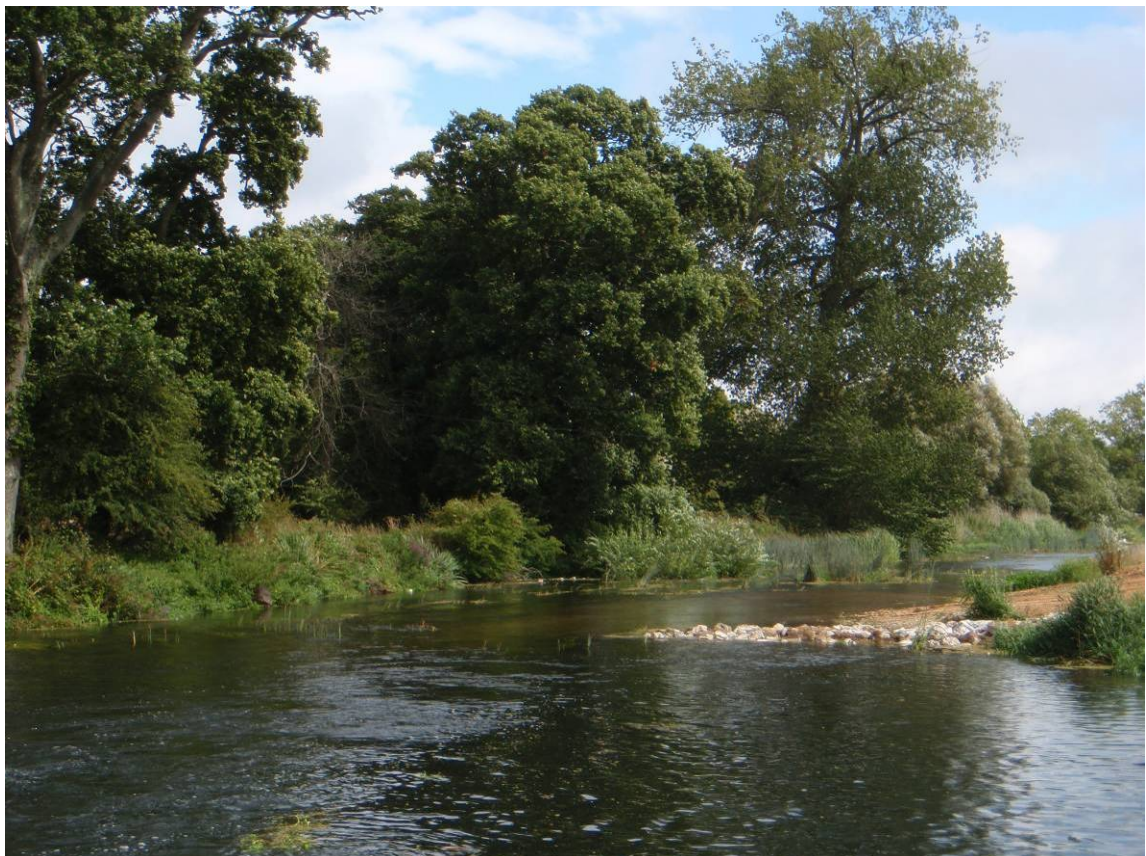
**Photo 8. Downstream deflector and re-profiled gravels post works**

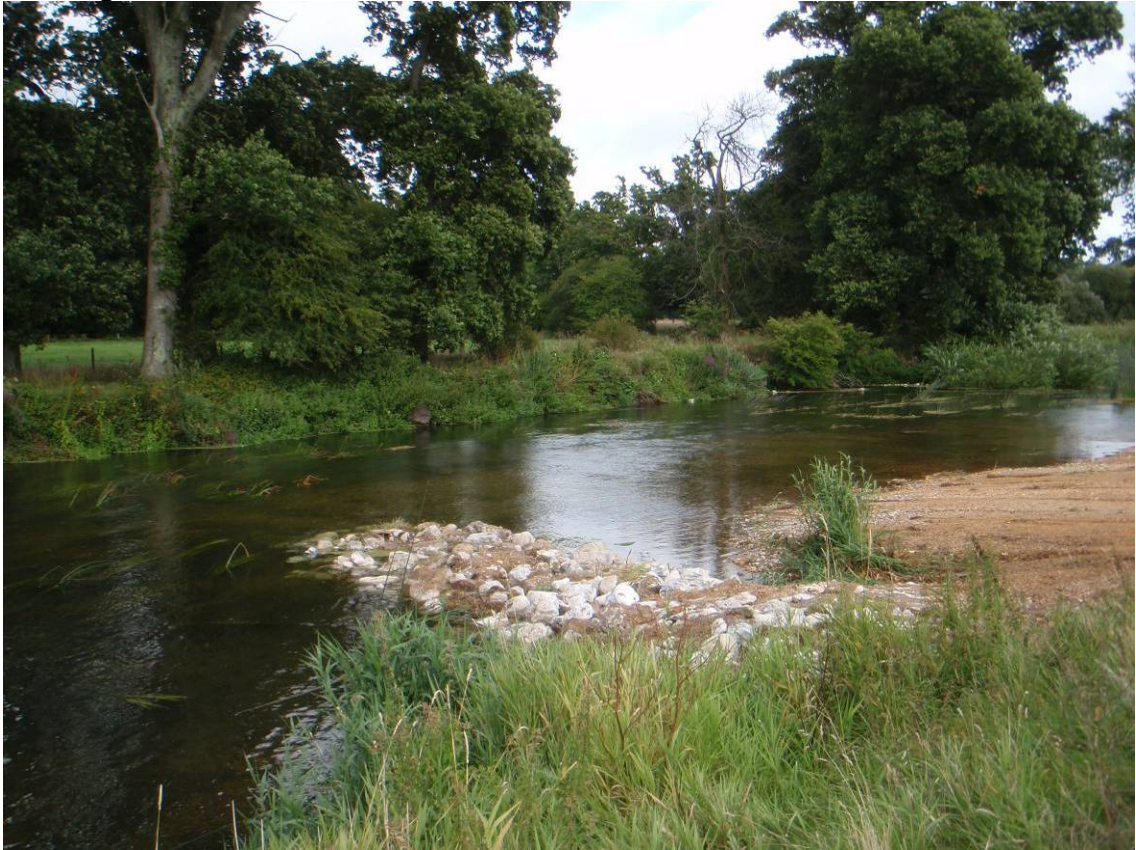
**Photo 9. Downstream deflector, re-profiled gravels and gravel berm looking downstream**

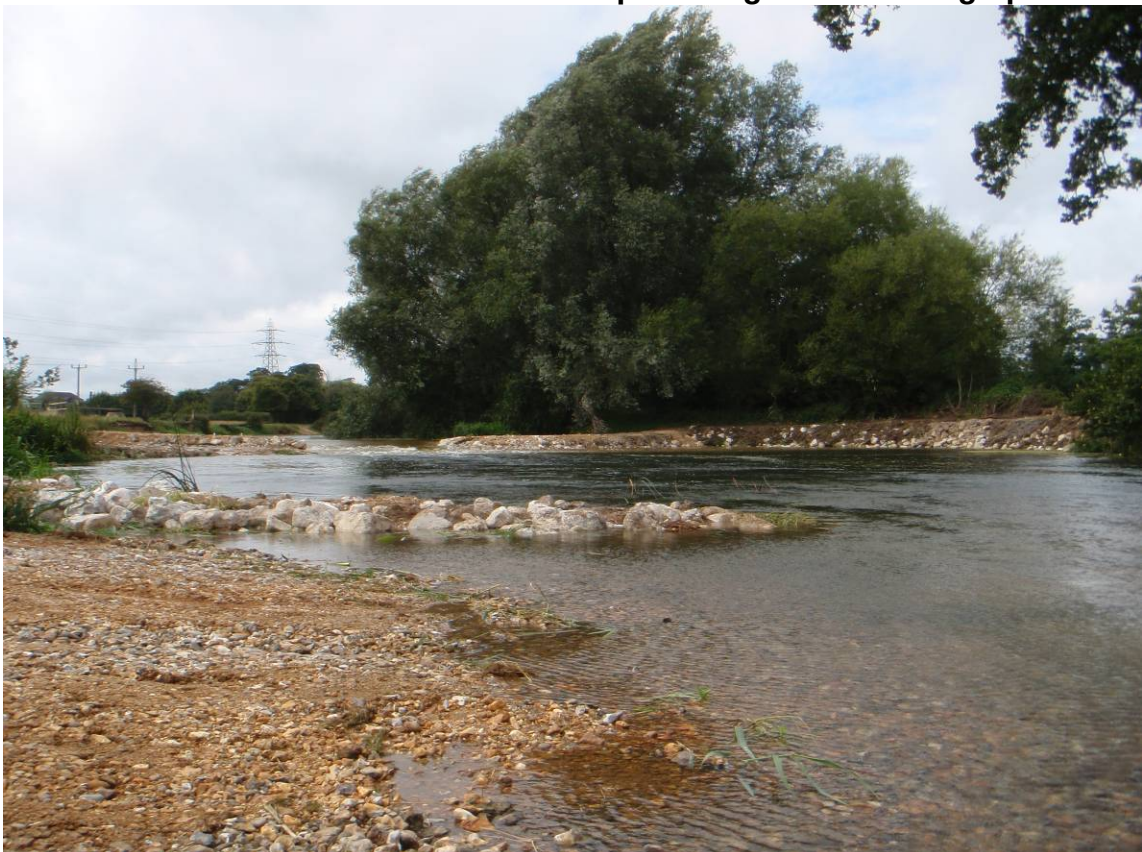
**Photo 10. Downstream deflector and re-profiled gravels looking upstream**

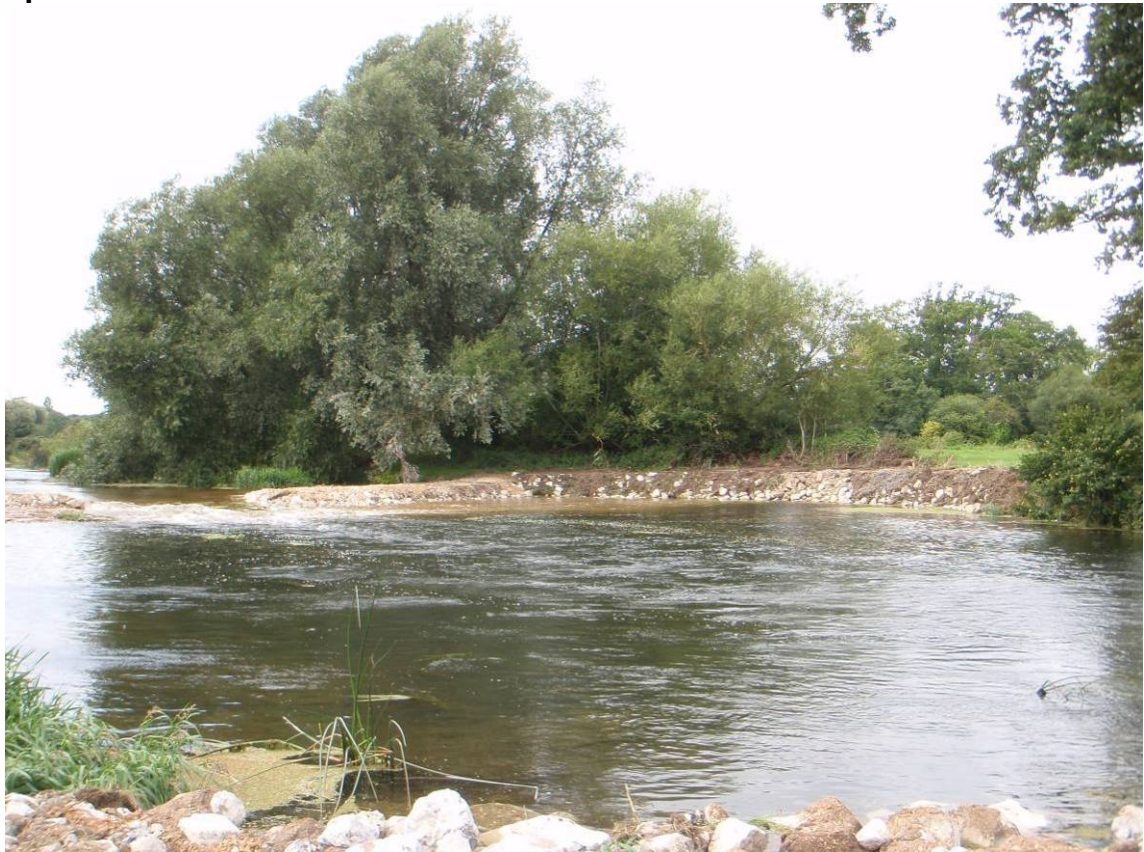
**Photo 11. Enhanced weir pool dynamics and bank stabilisation looking upstream**

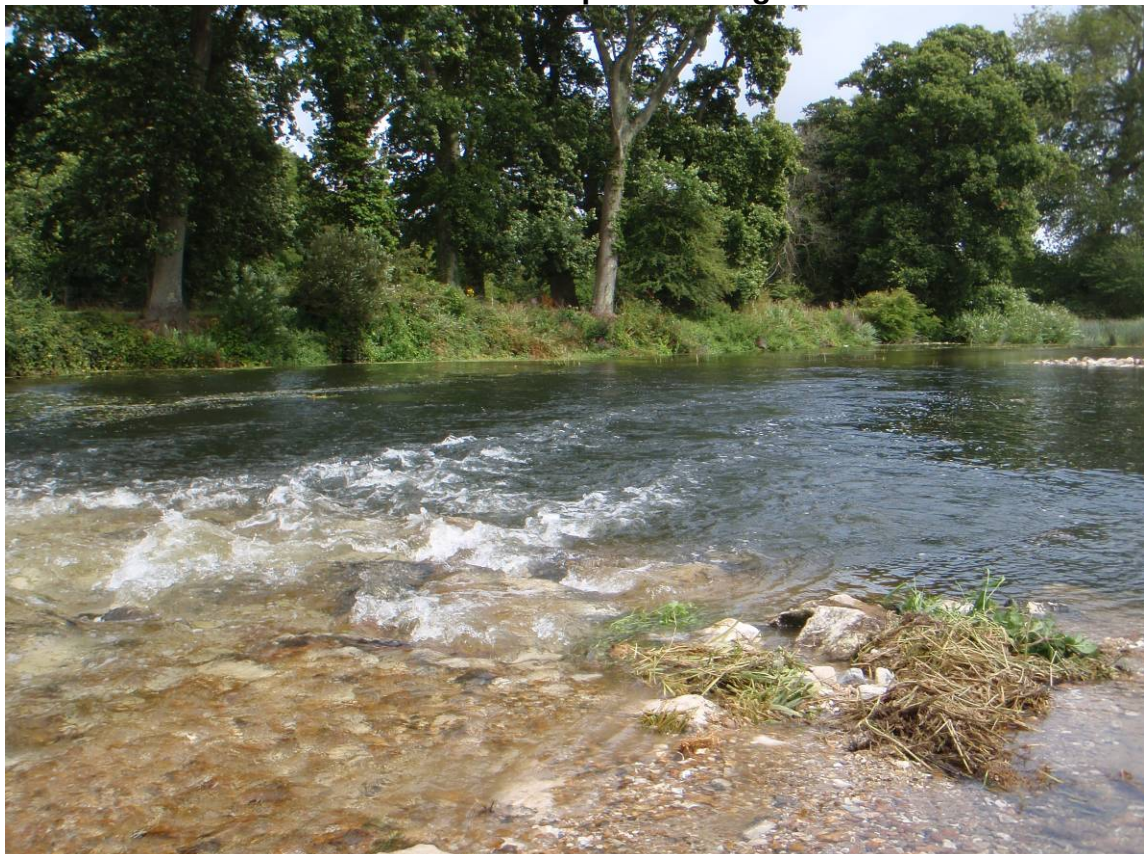
**Photo 12. Condensed flows into weir pool looking downstream**
